Home Inspection Report

Prepared for: Client's name

Address: For sale property

Inspection overview

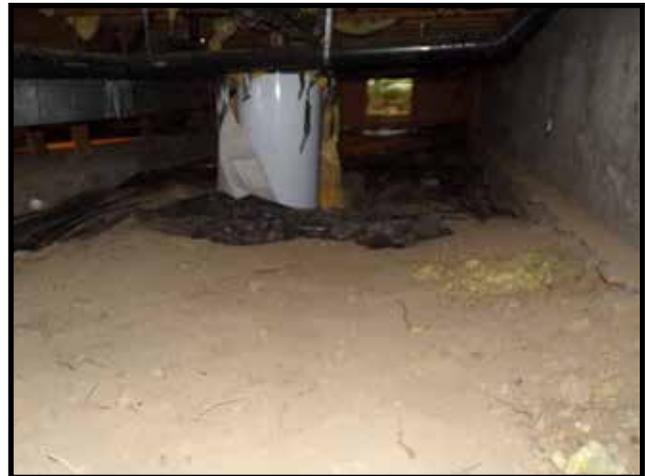
Fig. 1

The crawlspace can be accessed by a hatch on the exterior north side of the house. A 6mm black plastic vapor barrier is present, with a small area in the back corner that didn't appear to have any coverage (**See Fig. 1**). It's recommended some be installed here over the bare ground.

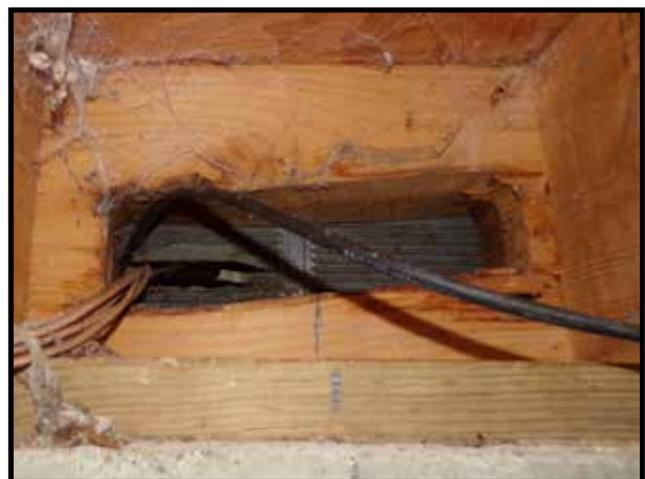
Fig. 2

The crawlspace has a number of vents with mesh coverings. One of the vents near the opening had a hole in it, likely made by a contractor installing communications wire (**See Fig. 2**). It's recommended some new mesh be installed to prevent possible rodent activity.

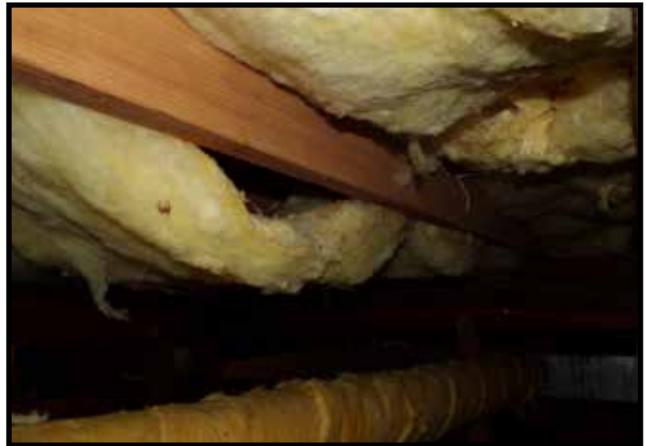
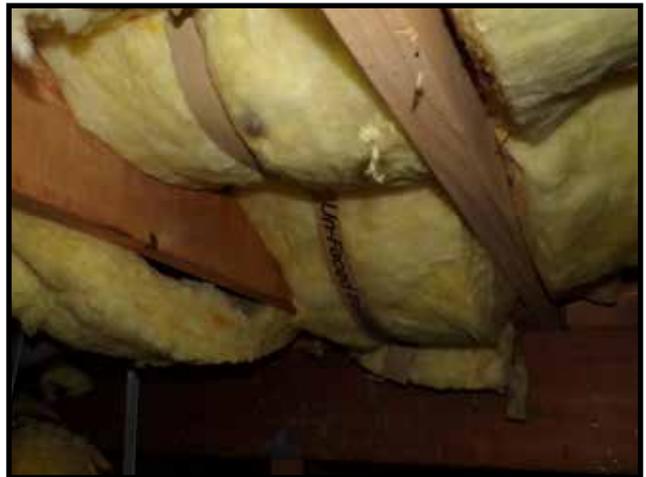
The flooring is insulated with fiber glass blanket insulation that was in **fair to average** condition at the time of the inspection. The installation method was a combination of metal wire hangers and two-sided tape. It looks as though not enough hangers were used, resulting in long spans of insulation that has caused it to sag over time (**See Fig. 3 & 4**).

It's recommended more insulation supports be installed to keep the insulation in place, and any missing or thin areas be replaced with new insulation.

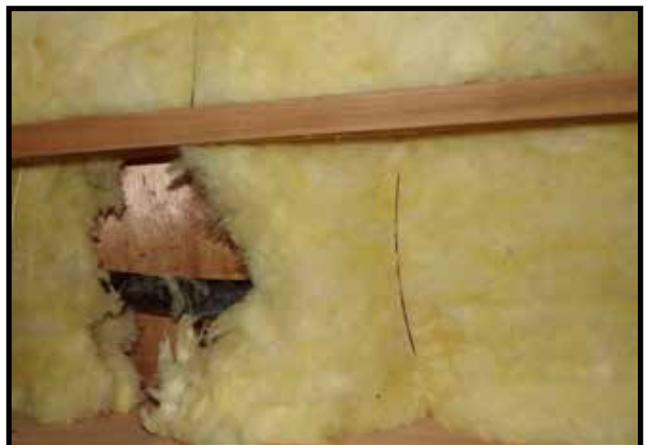
Fig. 5

There are also a few locations where the insulation has come down or thinned out (**See Fig. 5**). This is possibly because of the sagging, or an indication of past rodent activity, but there were no recent or current signs of rodents.

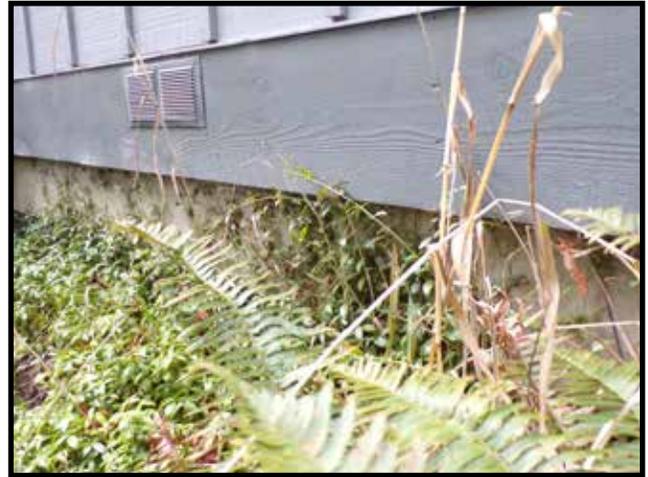
Fig. 6

There is a considerable amount of vegetation around the home. Most of it has been trimmed back from the structure of the house, but there were some locations with vegetation contact (See Fig. 6). It is recommended a minimum 18-inch gap be maintained between vegetation and the side of a house to promote better air flow and reduce moisture content on the siding. Vegetation in contact with the house can also be a bridge for insects.

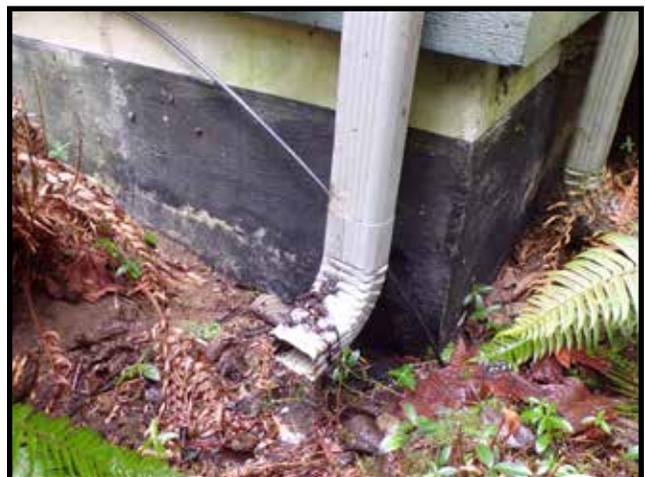
Fig. 7

The downspouts attached to the home drain directly next to the foundation (See Fig. 7). It is recommended splash blocks be placed under the downspouts to carry water runoff away from the foundation and help prevent potential hydrostatic pressure.

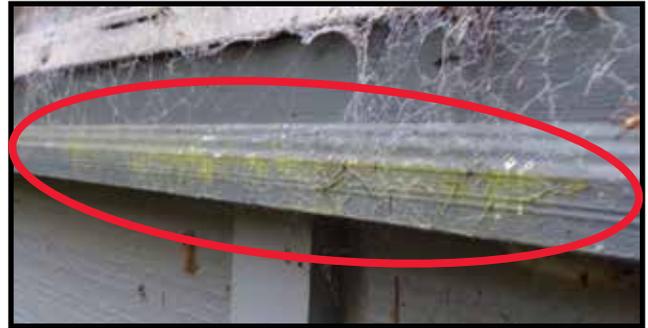
Fig. 8

Solid wood trim is installed around the house and on doors and windows. The trim was in **average** condition at the time of the inspection, with some minor bio-growth on the window trim on the north side of the house (See Fig. 8).

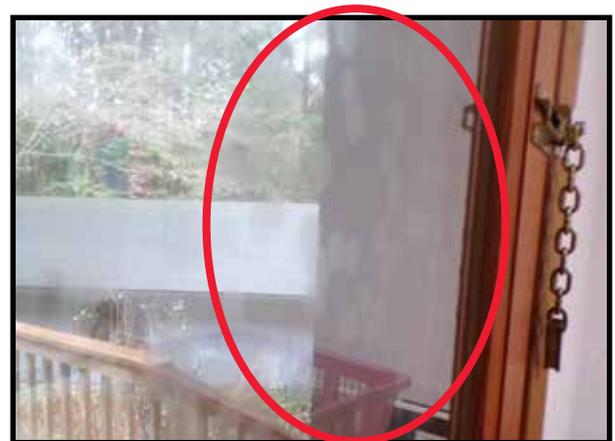
Fig. 9

The back window-door appeared to have a damaged seal in the window, resulting in condensation between the panes (See Fig. 9). This can result in a small loss of energy efficiency and is largely a cosmetic concern.

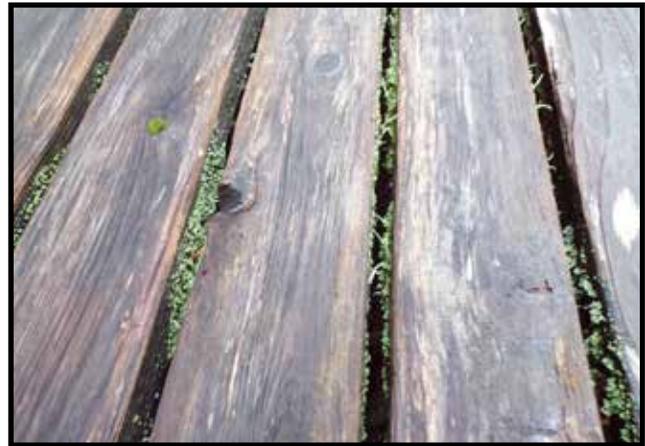
Fig. 10

The back deck was in **poor to fair** condition at the time of the inspection. There are a number of decking boards showing signs of rot and bio-growth (See Fig. 10).

This appears to be an ongoing issue as some of the boards look like they were recently replaced. Some nails were pulling out, and the older boards were slippery in the damp conditions.

The spacing of the balusters on the deck ranged from 5-6 inches. Modern code requires balusters on any deck higher than 36 inches to be no more than 4 inches apart, since anything wider is a fall-through hazard for children. There are no graspable handrails on the main steps going down to the back.

It's recommended boards be replaced as needed, additional balusters be attached, and code-compliant handrails be installed on the main stairs.

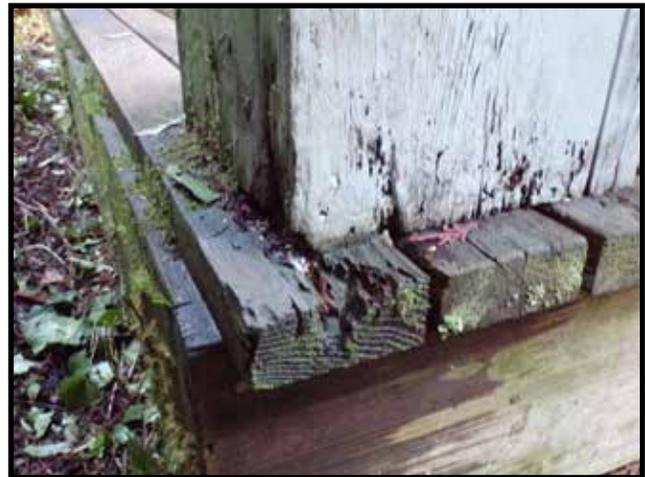
Fig. 11

The condition of the front porch was in **fair to average** condition at the time of the inspection. There are signs of rot in the boards at the front corners (See Fig. 11), and the end boards have considerable bio-growth. These could be the result of leaks from the gutters above (See Page 9). It's recommended these boards be replaced.

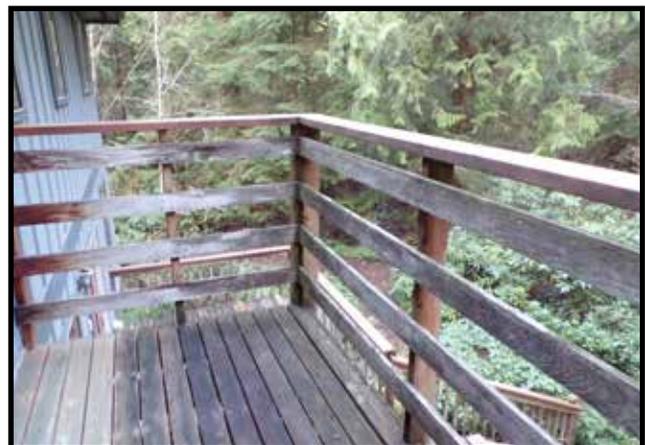
Fig. 12

Some of the decking on the balcony is showing signs of early rot. The spacing of the guard rails is too wide and represents a potential fall-through hazard for children (See Fig. 12). It's recommended boards be replaced as needed and additional guard rails be installed. The handrail and cantilevered joists holding the balcony were in **average** condition at the time of the inspection. These should be monitored in the future for signs of deterioration since this can lead to a safety hazard.

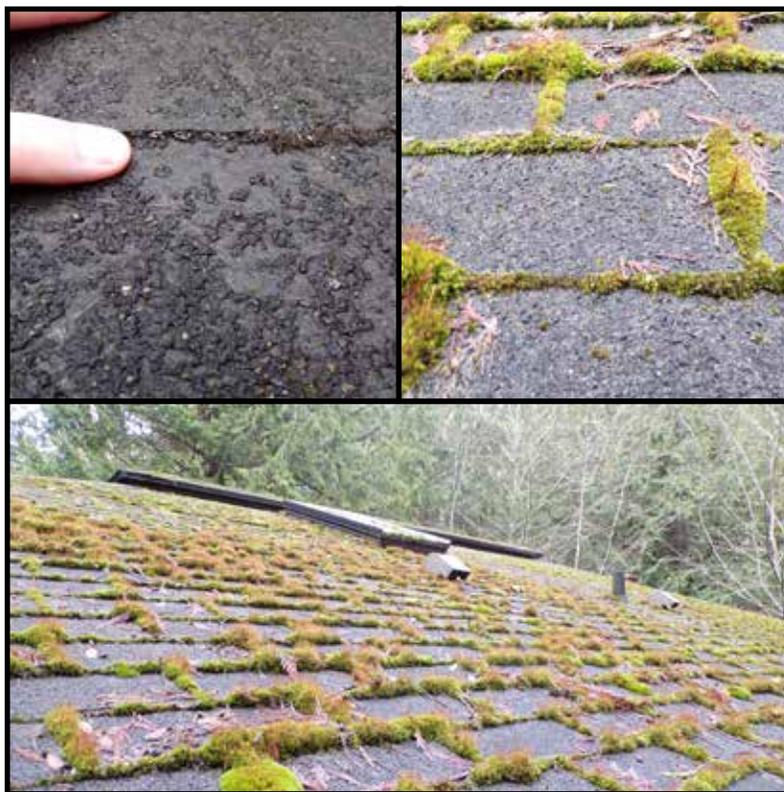
Fig. 13

the roof and conditions during the inspection, I observed the east surface from a ladder on the master bedroom balcony. The roof was in **poor** condition at the time of inspection.

The roof is showing signs of severe granular loss and is at the end of its lifespan (See Fig. 13). There was also considerable moss growth. There were no signs of active leaking in the attic at the time of the inspection, but it is recommended the roof be replaced as soon as possible.

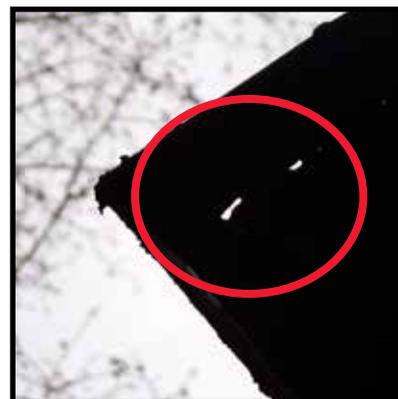
Fig. 14

Aluminum gutters and downspouts are installed around the house. The gutters were in **poor** condition at the time of the inspection. The upper gutters were full of debris and moss growth and showed signs of leaking although it was not raining at the time of the inspection. The gutters around the front porch were clear, but holes in the aluminum were observed (See Fig. 14). It is recommended the gutters and downspouts be replaced at the same time as the roof.

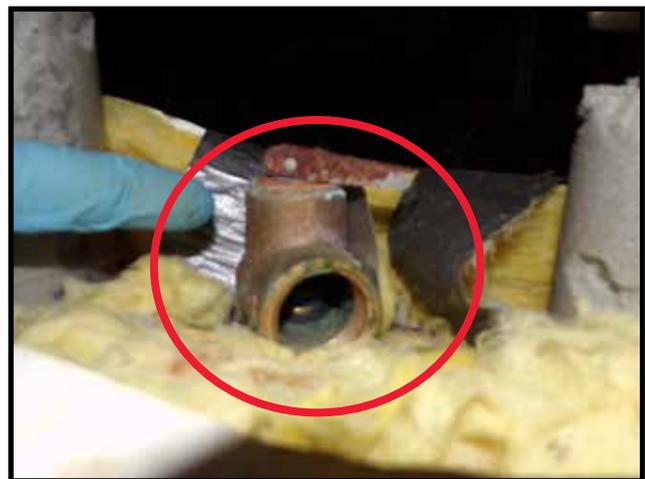
Fig. 15

There is no earthquake strapping on the water heaters, and I was unable to determine if they are adequately secured to the ground. TPR valves

(Temperature Pressure Relief) are present on both tanks, however, none of the necessary piping associated with these valves is in place (See Fig. 15). A certified plumber should be hired to assess the earthquake security and TPR valve piping as soon as possible.

The manufacturer's date listed on the label is 1985, putting the age of the heaters at 34 years. The average lifespan of a water heater is 8-12 years, so these are obviously well past that. The life of the water heaters has likely been extended due to not being used frequently, but there is still a high likelihood they will need replacing in the near future.

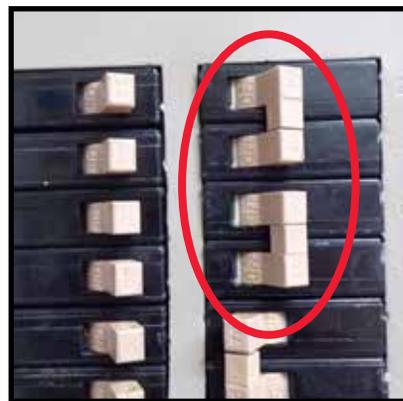
Fig. 16

The main panel appeared to be properly wired at the time of the inspection. The breakers for the hot water heaters were turned off at the time of the inspection (See Fig. 16).

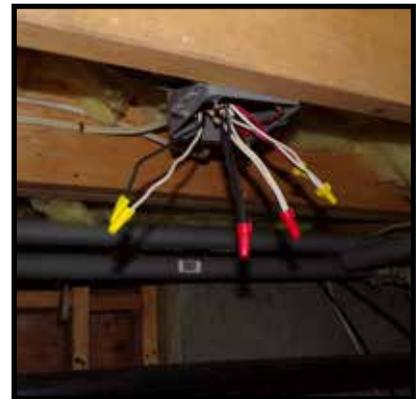
Fig. 17

There is an open junction box in the crawlspace (See Fig. 17). The wires all had wire nuts installed, but a cover should still be placed over the box.

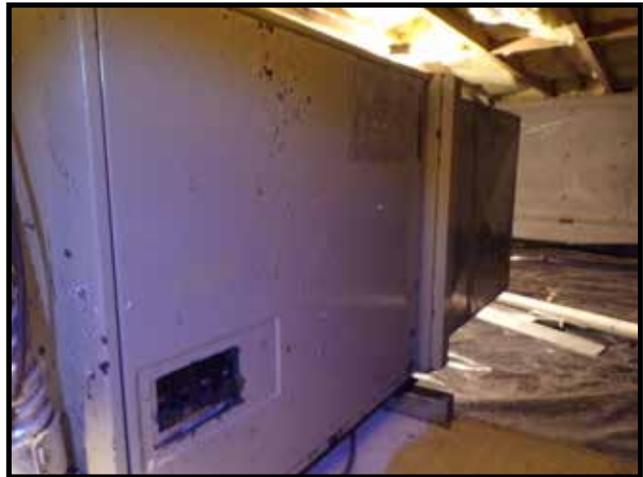
Fig. 18

A Trane electric furnace is located in the crawl-space (See Fig. 18). The unit was operating as designed during the inspection. The field-installed stamp on the furnace listed the installation date as 1984, putting the age of the unit at 35 years.

The average lifespan of an electric furnace is 20-30 years, but depending on how well they're maintained and how often they're used, they can last longer. It's recommended to have the furnace serviced annually, and when it is time to replace it, do so with a more economical heat pump.

There were some minor rust spots on the exterior of the unit.

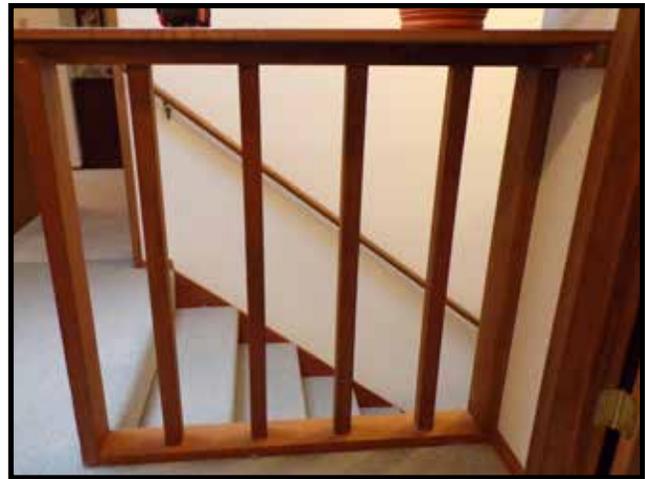
Fig. 19

The balusters at the top of the stairs are spaced at approximately 5½ inches, creating a fall-through hazard for children (See Fig. 19). It's recommended balusters be installed to narrow the spaces to a minimum of 4 inches.

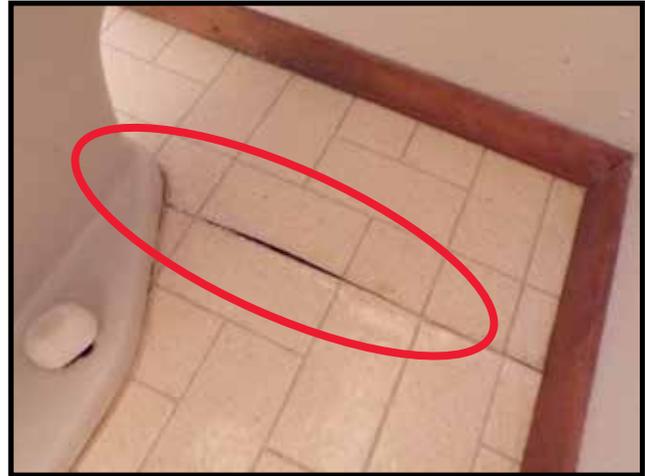
Fig. 20

The carpet in a few locations had minor staining of cosmetic concern only. The vinyl flooring in the master bathroom had a peeling seam behind the toilet (See Fig. 20). Because this is an area with a high likelihood of getting wet, it's recommended the seam be sealed to prevent water infiltration to the sub-flooring.

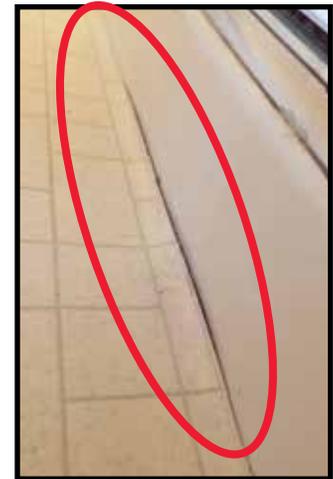
Fig. 21

The caulking along the base of the shower in the master bathroom and the bathtub in the second bathroom has deteriorated and allowed the flooring to start curling away in some areas. (See Fig. 21). Because this is a wet area, I recommend applying adhesive to the flooring and re-caulking to prevent water infiltration to the sub-flooring.

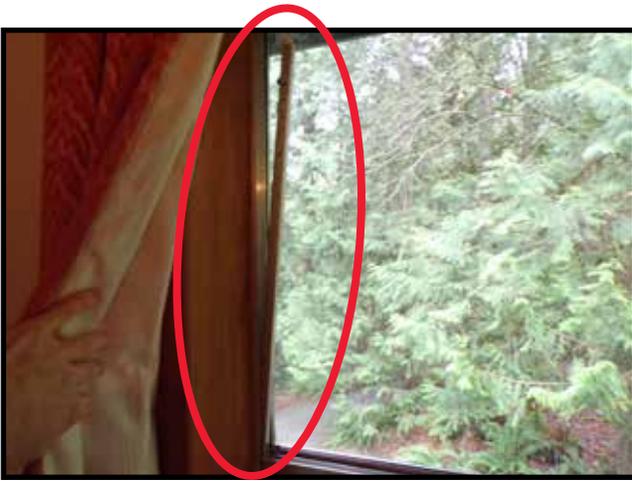
The balance (mechanism that keeps the sash from falling down when it's open) is broken on the left window in the master bedroom. The balance should be replaced before operating the window because it won't stay open and is a safety hazard when it slams shut.

Broken balance on master bedroom window

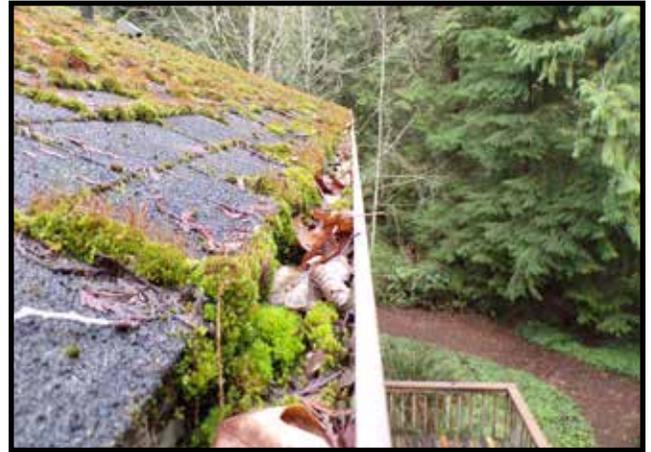
Clogged gutters on upper roof

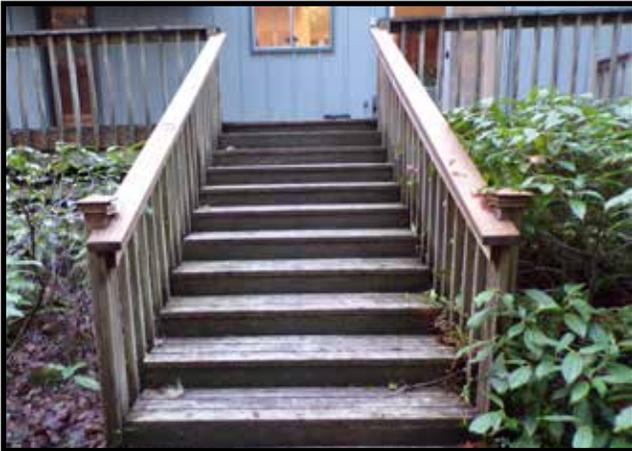
Deck stairs without proper handrail

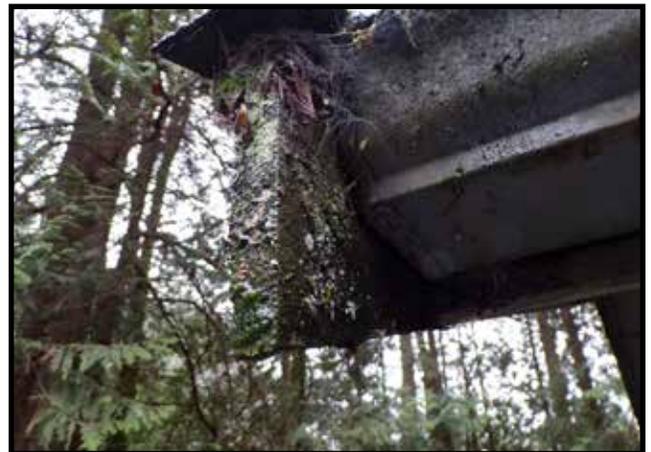
The ends of the fascia on the detached garage are showing signs of rot, including soft-to-the-touch wood, and should be replaced.

Signs of rot on garage fascia
